**Flood Control Project Maintenance
Levee Inspections**

Fall 2016 Levee Maintenance Deficiency Summary Report

Sacramento River Basin

Sacramento Maintenance Yard Maintenance Area 0004

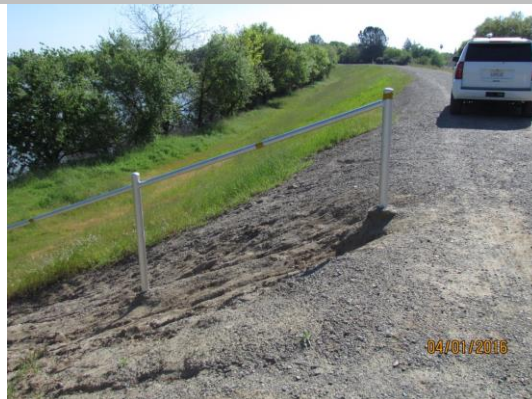
Photo 1 of 1 : FA_2016_MA0004_298_16_20160913_00009.jpg

LM Start	0.00	Rating **	M	Issue No.	16
LM End	0.00	Issue Type +	Ma	Location *	WS
Category	Earthen Levee			GPS Latitude/Longitude	
				Start	End
Item	Slope Stability			38.596823 °	38.596823 °
				-121.547608 °	-121.547608 °
DWR ID	DWR_MA0004_01_s_2016_16				
Comment Code					
S2 : Repair the levee slope damaged by foot traffic and prevent access where possible.					
Inspector Comment

View of the slope stability on the waterward side of the levee looking downstream. Spring 2016.

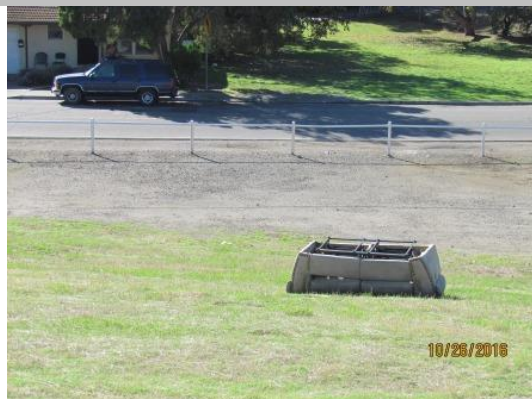
Photo 1 of 1 : FA_2016_MA0004_298_6_20161027_00031.jpg

LM Start	0.06	Rating **	M	Issue No.	6
LM End	0.06	Issue Type +	Ma	Location *	LS
Category	Earthen Levee			GPS Latitude/Longitude	
				Start	End
Item	Encroachments			38.596649 °	38.596649 °
				-121.546575 °	-121.546575 °
DWR ID	DWR_MA0004_01_f_2016_6				
Comment Code					
GA : Garbage					
Inspector Comment

Garbage on landside slope. Fall 2016.

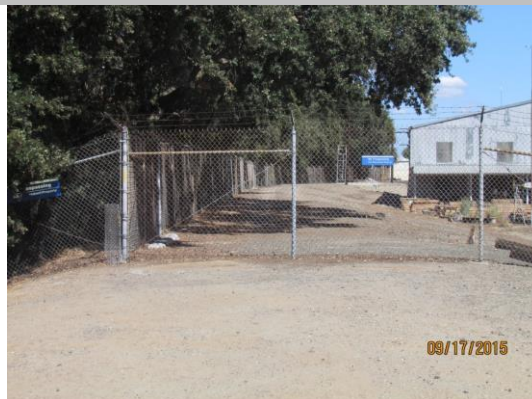
Photo 1 of 1 : FA_2016_MA0004_298_2_20160913_00001.jpg

LM Start	0.24	Rating **	U	Issue No.	2
LM End	0.24	Issue Type +	En	Location *	CR
Category	Earthen Levee			GPS Latitude/Longitude	
				Start	End
Item	Encroachments			38.597193°	38.597193°
				-121.543421°	-121.543421°
DWR ID	DWR_MA0004_01_s_2012_2				
Comment Code					
FE : Fence					
Inspector Comment					
This is the USACE yard and the chain link fence crosses the levee. The fence runs the length of the yard on the crown.

View of the fence blocking access on the crown of the levee looking downstream. Fall 2015.

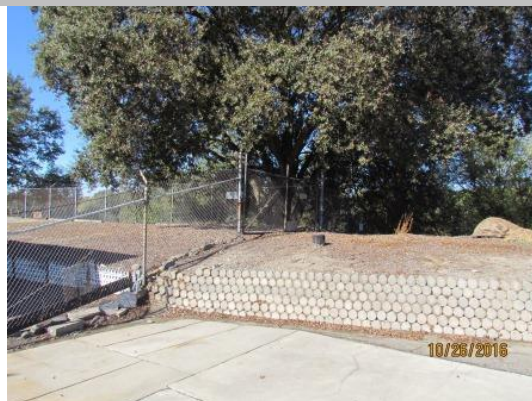
Photo 1 of 1 : FA_2016_MA0004_298_15_20161027_00032.jpg

LM Start	0.41	Rating **	U	Issue No.	15
LM End	0.41	Issue Type +	En	Location *	CR
Category	Earthen Levee			GPS Latitude/Longitude	
				Start	End
Item	Encroachments			38.598661 °	38.598661 °
				-121.540895 °	-121.540895 °
DWR ID	DWR_MA0004_01_f_2016_15				
Comment Code					
FE : Fence					
Inspector Comment					
Chain link fence crosses the levee. USACE facility.

View of fence crossing the crown on NE side of USACE facility. Fall 2016.

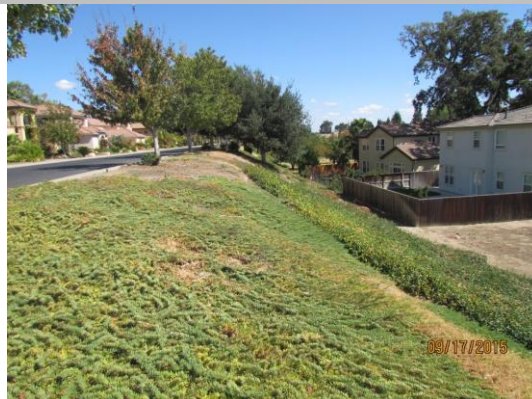
Photo 1 of 1 : FA_2016_MA0004_298_7_20160913_00002.jpg

LM Start	1.34	Rating **	A/W	Issue No.	7
LM End	1.97	Issue Type +	En	Location *	LS
Category	Earthen Levee			GPS Latitude/Longitude	
				Start	End
Item	Vegetation			38.602761 °	38.600449 °
				-121.525566 °	-121.514459 °
DWR ID	DWR_MA0004_01_s _ 2012_7				
Comment Code					
V6 : Landscaping					
Inspector Comment					
The Rivers housing development

View of the landscaping on the landward side of the levee looking downstream. Fall 2015.

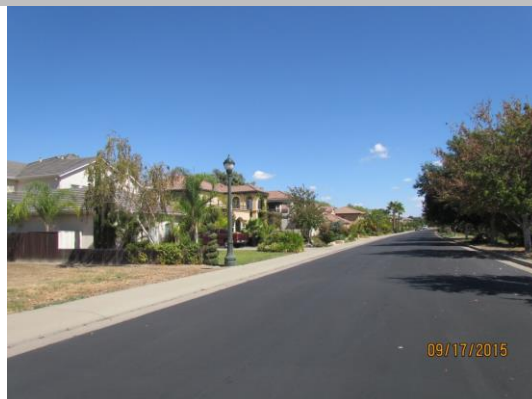
Photo 1 of 1 : FA_2016_MA0004_298_8_20160913_00003.jpg

LM Start	1.36	Rating **	A/W	Issue No.	8
LM End	1.51	Issue Type +	En	Location *	CR
Category	Earthen Levee			GPS Latitude/Longitude	
				Start	End
Item	Encroachments			38.602770 °	38.602591 °
				-121.525275 °	-121.522382 °
DWR ID	DWR_MA0004_01_s _ 2012_8				
Comment Code					
BU : Building					
Inspector Comment					
The Rivers housing development houses on crown of levee waterside

View of the houses on the crown of the levee looking downstream. Fall 2015.

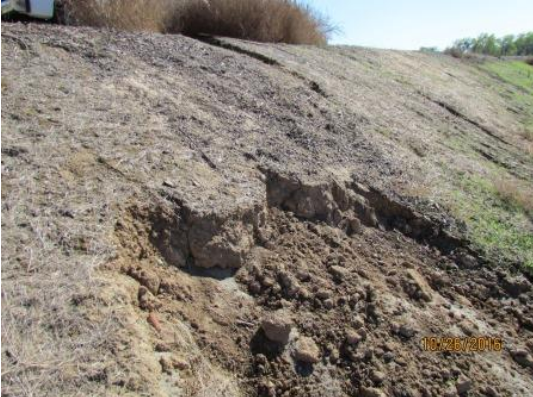
Photo 1 of 1 : FA_2016_MA0004_298_19_20161027_00035.jpg

Landside slope erosion near the crown and toward levee toe. Fall 2016.

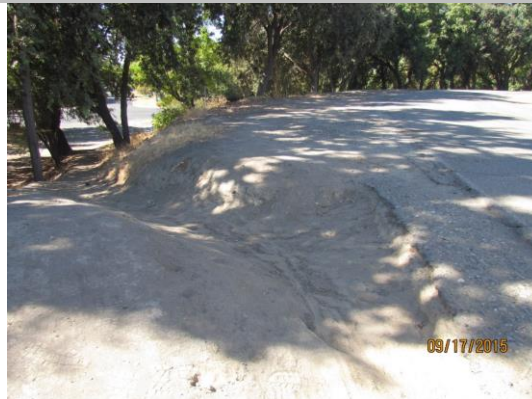
Photo 1 of 1 : FA_2016_MA0004_298_22_20160913_00011.jpg

LM Start	2.65	Rating **	M	Issue No.	22
LM End	2.65	Issue Type +	Ma	Location *	LS
Category	Earthen Levee			GPS Latitude/Longitude	
				Start	End
Item	Slope Stability			38.591380 °	38.591380 °
				-121.511345 °	-121.511345 °
DWR ID	DWR_MA0004_01_f_2015_22				
Comment Code					
S2 : Repair the levee slope damaged by foot traffic and prevent access where possible.					
Inspector Comment

View of the depression on the landward side of the levee due to foot traffic looking upstream. Fall 2015.

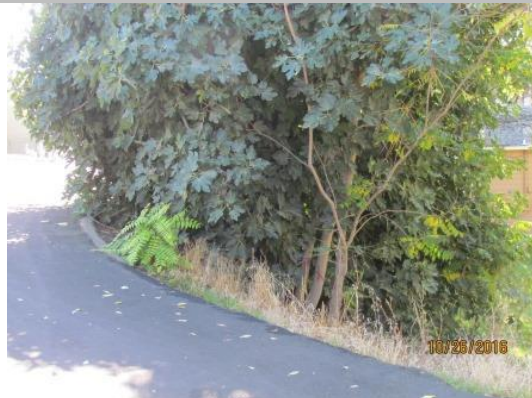
Photo 1 of 1 : FA_2016_MA0004_298_21_20161027_00037.jpg

LM Start	2.67	Rating **	M	Issue No.	21
LM End	2.68	Issue Type +	En	Location *	LS
Category	Earthen Levee			GPS Latitude/Longitude	
				Start	End
Item	Vegetation			38.591228 °	38.591080 °
				-121.511130 °	-121.510994 °
DWR ID	DWR_MA0004_01_f_2016_21				
Comment Code					
V6 : Landscaping					
Inspector Comment

View of small trees that block visibility of LS slope. Fall 2016.

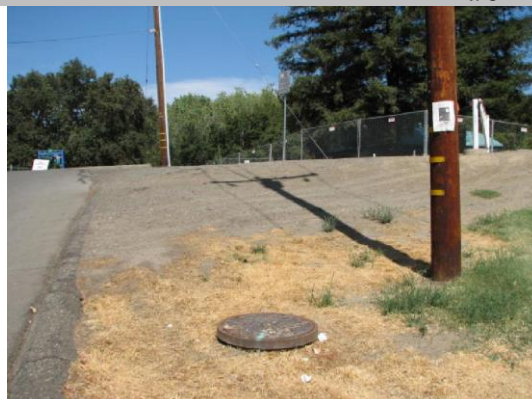
Photo 1 of 2 : UCIP_FA_2016_41443_9371.jpg

LM Start	2.69	Rating **	M	Issue No.	39
LM End	2.69	Issue Type +	En	Location *	LS
Category	Supplemental			GPS Latitude/Longitude	
				Start	End
Item	DWR UCIP Field Study			38.590910 °	38.590910 °
				-121.510830 °	-121.510830 °
DWR ID					
Comment Code					
Inspector Comment					
FS_ID:41443 DS_ID:19405 EP_NO: N/A Repair Type: Non-Urgent Crossing Status: Found UCIP Comments: Found during the field survey, not listed in the desk study. FIELD_STRUCT_DESC: A 6-inch sewer line from the public facility of boat launching area. No other details available. FS Date: 9/12/2012

Landside view- manhole on the side of the levee and a road.

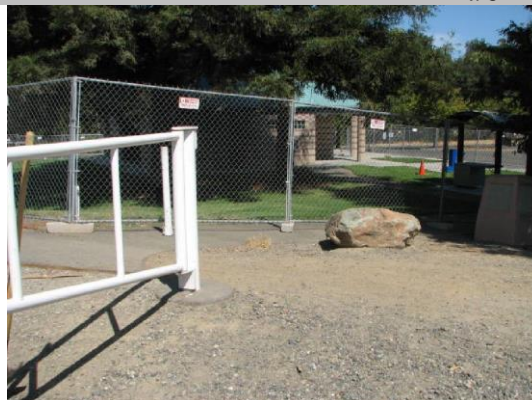
Photo 2 of 2 : UCIP_FA_2016_41443_9370.jpg

Waterside view- public facility in the background.

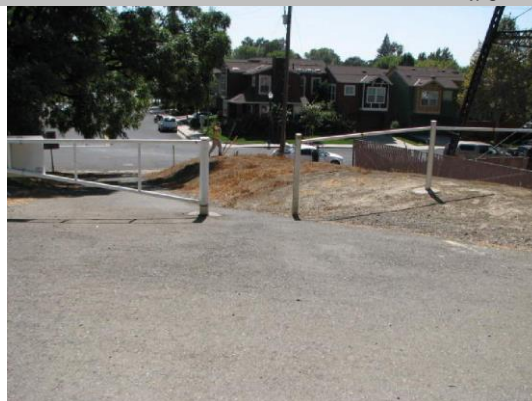
Photo 1 of 2 : UCIP_FA_2016_41485_9367.jpg

LM Start	2.77	Rating **	M	Issue No.	36
LM End	2.77	Issue Type +	En	Location *	LS
Category	Supplemental			GPS Latitude/Longitude	
				Start	End
Item	DWR UCIP Field Study			38.590140 °	38.590140 °
				-121.509750 °	-121.509750 °
DWR ID					
Comment Code					
Inspector Comment					
FS_ID:41485 DS_ID:19406 EP_NO: N/A Repair Type: Non-Urgent Crossing Status: Found UCIP Comments: Found during field survey. Not listed in the desk study. FIELD_STRUCT_DESC: 1 of 2. A 3-inch wrapped GI water pipe(of 3-inch and 5-inch water pipe) daylight in a metal cage box. A valve box for the pipe is also found. FS Date: 9/12/2012

Landside overview

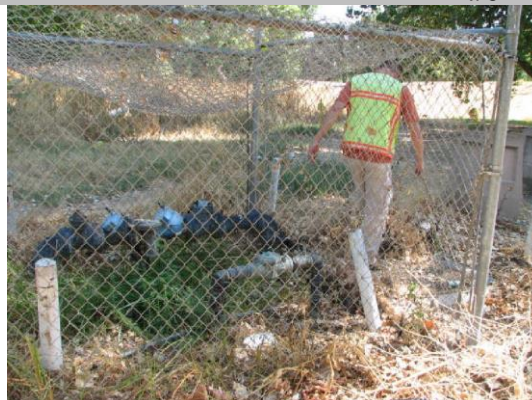
Photo 2 of 2 : UCIP_FA_2016_41485_9366.jpg

Waterside view- pipe daylight in a metal cage.

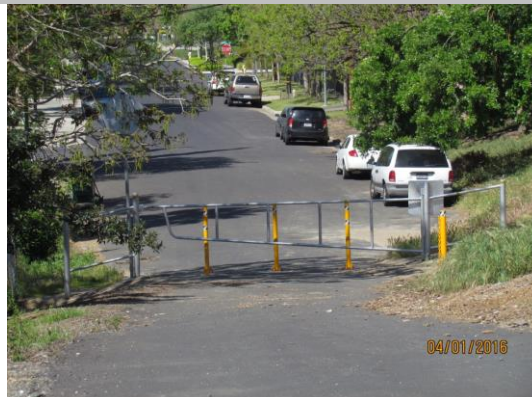
Photo 1 of 2 : FA_2016_MA0004_298_35_20160913_00019.jpg

LM Start	2.82	Rating **	M	Issue No.	35
LM End	2.82	Issue Type +	En	Location *	LS
Category	Earthen Levee			GPS Latitude/Longitude	
				Start	End
Item	Encroachments			38.589800 °	38.589800 °
				-121.508996 °	-121.508996 °
DWR ID	DWR_MA0004_01_s_2016_35				
Comment Code					
PO : Pole					
Inspector Comment

Bollards are blocking the access gate on the levee ramp. Spring 2016.

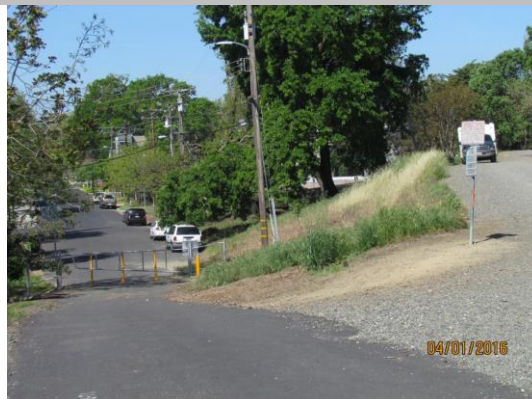
Photo 2 of 2 : FA_2016_MA0004_298_35_20160913_00020.jpg

Perspective view of the bollards at the levee toe looking upstream. Spring 2016.

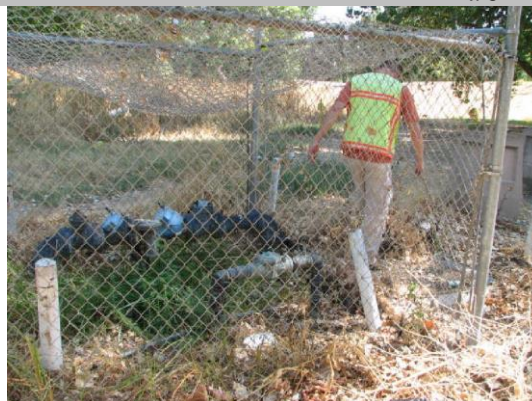
Photo 1 of 2 : UCIP_FA_2016_41486_9369.jpg

LM Start	2.82	Rating **	M	Issue No.	37
LM End	2.82	Issue Type +	En	Location *	LS
Category	Supplemental			GPS Latitude/Longitude	
				Start	End
Item	DWR UCIP Field Study			38.590130 °	38.590130 °
				-121.508740 °	-121.508740 °
DWR ID					
Comment Code					
Inspector Comment					
FS_ID:41486 DS_ID:19407 EP_NO: N/A Repair Type: Non-Urgent Crossing Status: Found UCIP Comments: Found during field survey, not listed in the desk study. FIELD_STRUCT_DESC: 2 of 2. A 5-inch wrapped GI water pipe(of 3-inch and 5-inch water pipe) daylight in a metal cage box. A valve box for the pipe is also found. FS Date: 9/12/2012

Waterside view- pipe daylight in a cage.

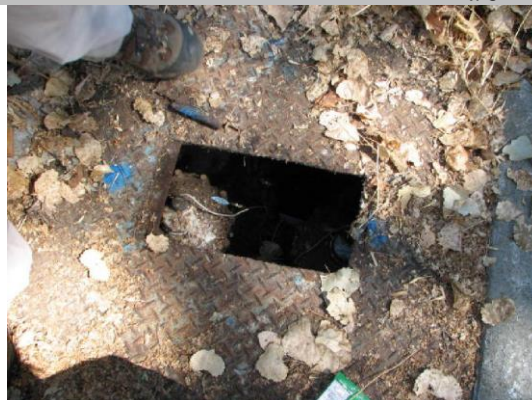
Photo 2 of 2 : UCIP_FA_2016_41486_9368.jpg

Waterside view- manhole/control valve.

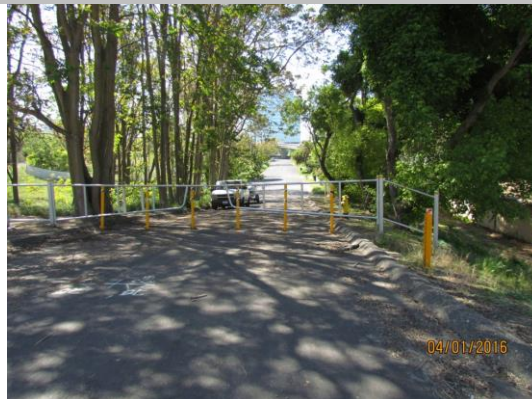
Photo 1 of 3 : FA_2016_MA0004_298_34_20160913_00016.jpg

LM Start	2.86	Rating **	M	Issue No.	34
LM End	2.86	Issue Type +	En	Location *	LS
Category	Earthen Levee			GPS Latitude/Longitude	
				Start	End
Item	Encroachments			38.589518 °	38.589518 °
				-121.508412 °	-121.508412 °
DWR ID	DWR_MA0004_01_s_2016_34				
Comment Code					
PO : Pole					
Inspector Comment					
Bollard is blocking access to the levee.

The City of West Sacramento has put bollards and blocked access to the gates. Spring 2016.

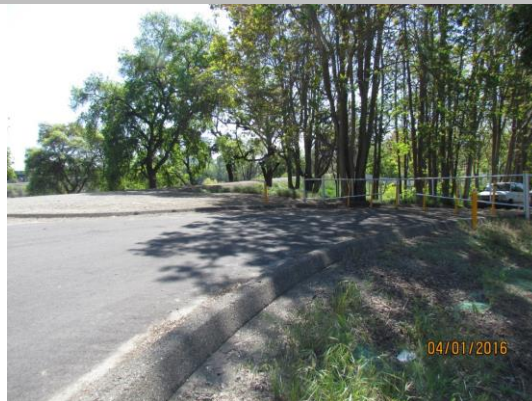
Photo 2 of 3 : FA_2016_MA0004_298_34_20160913_00017.jpg

Perspective view of the bollards looking downstream. Spring 2016.

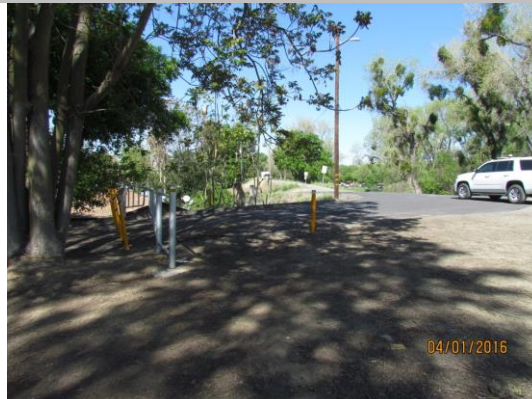
Photo 3 of 3 : FA_2016_MA0004_298_34_20160913_00018.jpg

Perspective view of the bollards on the landward side looking upstream. Spring 2016.

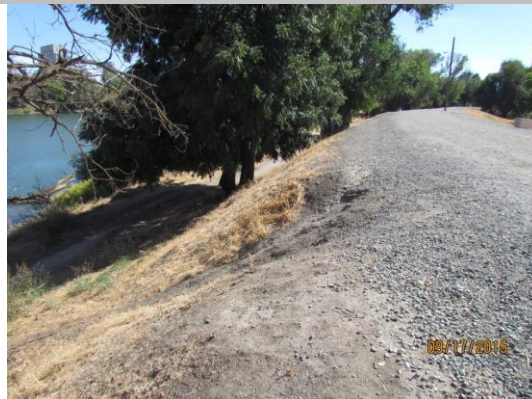
Photo 1 of 1 : FA_2016_MA0004_298_24_20160913_00012.jpg

LM Start	2.91	Rating **	M	Issue No.	24
LM End	2.91	Issue Type +	Ma	Location *	WS
Category	Earthen Levee			GPS Latitude/Longitude	
				Start	End
Item	Slope Stability			38.588937 °	38.588937 °
				-121.507920 °	-121.507920 °
DWR ID	DWR_MA0004_01_f_2015_24				
Comment Code					
S2 : Repair the levee slope damaged by foot traffic and prevent access where possible.					
Inspector Comment

View of the slope stability due to foot traffic on the waterward side of the levee looking downstream. Fall 2015.

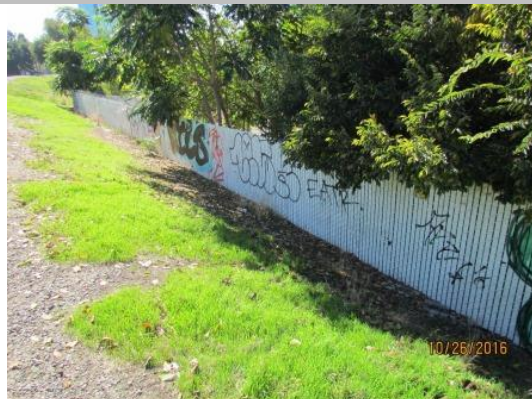
Photo 1 of 1 : FA_2016_MA0004_298_23_20161027_00038.jpg

LM Start	2.92	Rating **	M	Issue No.	23
LM End	2.95	Issue Type +	En	Location *	LS
Category	Earthen Levee			GPS Latitude/Longitude	
				Start	End
Item	Encroachments			38.588762 °	38.588384 °
				-121.507951 °	-121.507894 °
DWR ID	DWR_MA0004_01_f_2016_23				
Comment Code					
FE : Fence					
Inspector Comment

View of fence on LS slope. Fall 2016.

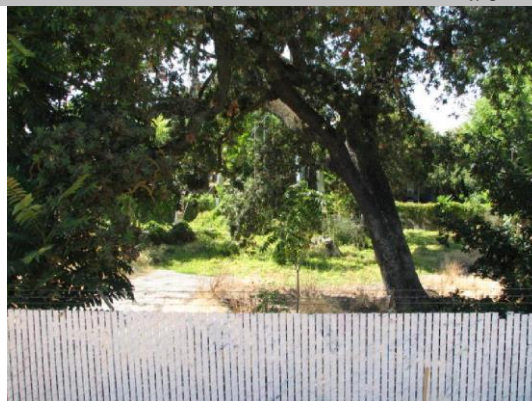
Photo 1 of 2 : UCIP_FA_2016_41557_9767.jpg

LM Start	2.93	Rating **	M	Issue No.	38
LM End	2.93	Issue Type +	En	Location *	LS
Category	Supplemental			GPS Latitude/Longitude	
				Start	End
Item	DWR UCIP Field Study			38.588688 °	38.588688 °
				-121.507910 °	-121.507910 °
DWR ID					
Comment Code					
Inspector Comment					
FS_ID:41557 DS_ID:18883 EP_NO: N/A Repair Type: Non-Urgent Crossing Status: Found UCIP Comments: Abandoned 7-inch pipe found. Needs to be abandoned properly. FIELD_STRUCT_DESC: *ABANDONED* 2 of 4. An abandoned 7-inch pipe of one 3-inch, two 7-inch and one 10-inch pipes through the levee 18.6 feet below the crown. Unable to locate. Pipes exposed and extend 10 feet from bank. O&M Manual Sac 116, August 1955, Revision Year 2011. FS Date: 9/12/2012

Land side view- Water tower area.

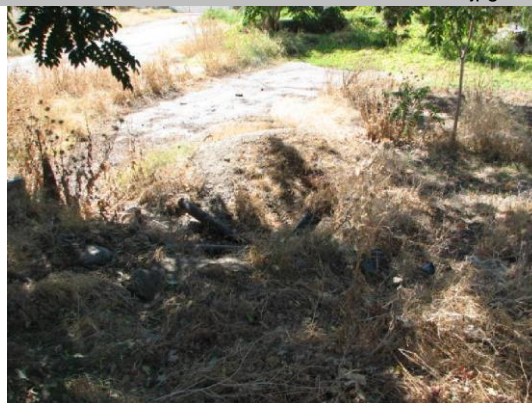
Photo 2 of 2 : UCIP_FA_2016_41557_9770.jpg

Land side view- abandoned pipes inside the tower area

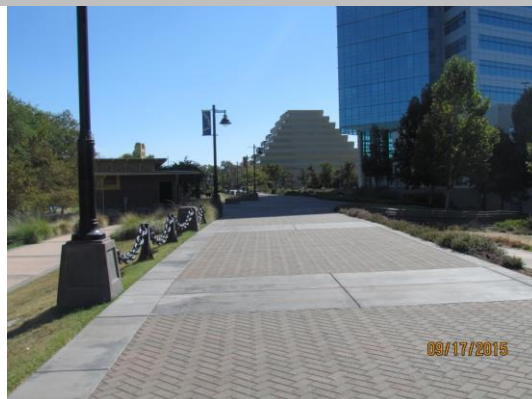
Photo 1 of 2 : FA_2016_MA0004_298_12_20160913_00004.jpg

The Riverwalk is part of the landscape on the levee. Fall 2015.

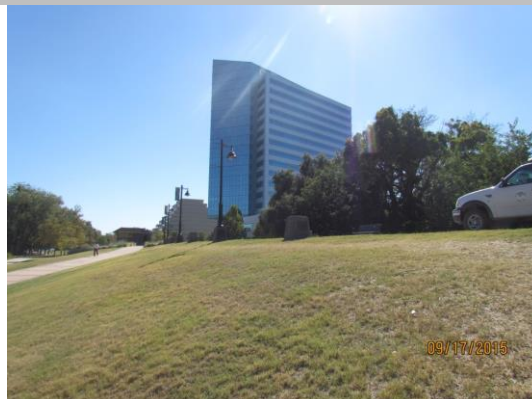
Photo 2 of 2 : FA_2016_MA0004_298_12_20160913_00005.jpg

Landscaping and buildings are on the crown and waterward side of the levee. Fall 2015.

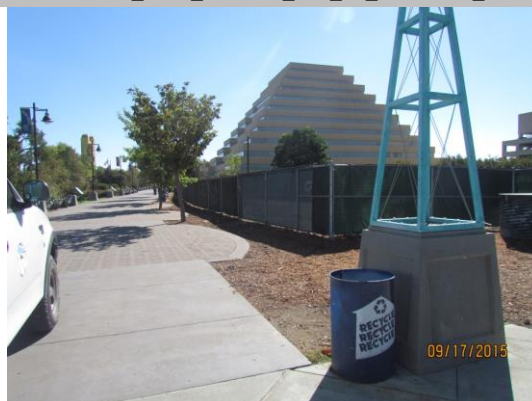
Photo 1 of 2 : FA_2016_MA0004_298_27_20160913_00013.jpg

LM Start	3.24	Rating **	M	Issue No.	27
LM End	3.29	Issue Type +	En	Location *	LS
Category	Earthen Levee			GPS Latitude/Longitude	
				Start	End
Item	Encroachments			38.584168 °	38.583435 °
				-121.508632 °	-121.508785 °
DWR ID	DWR_MA0004_01_f_2015_27				
Comment Code					
FE : Fence					
Inspector Comment					
There is a fence at the shoulder of the levee crown. There seems to be no work being done inside of the fence as of 9/17/2015.

View of the fence on the crown of the levee looking downstream. Fall 2015.

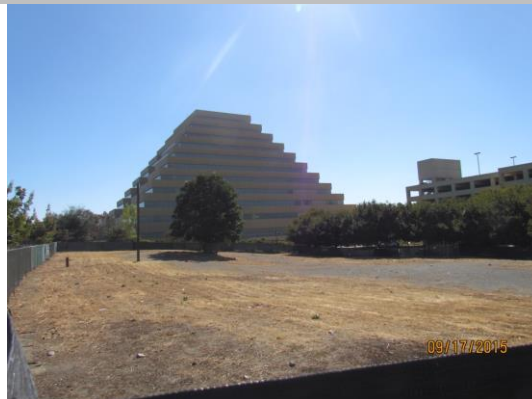
Photo 2 of 2 : FA_2016_MA0004_298_27_20160913_00014.jpg

View of the inside of the fence looking downstream. Fall 2015.
